**Toward Universal Access: Americans with Disabilities Act
Sidewalk and Curb Ramp Self-Evaluation Report
for the City of Bellevue**

September 2009

ADA Self-Evaluation Report

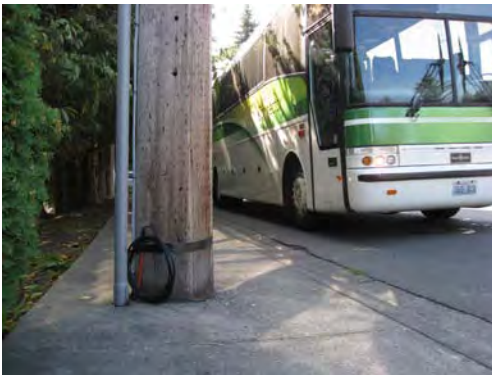
Fixed obstructions.

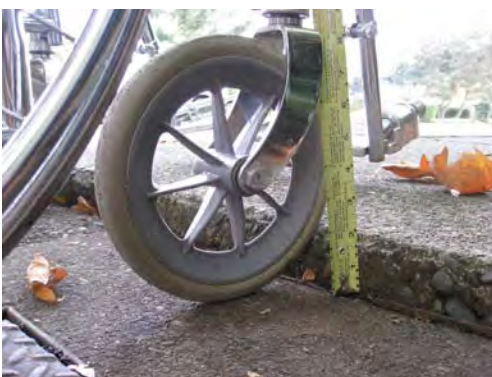
Change in level.

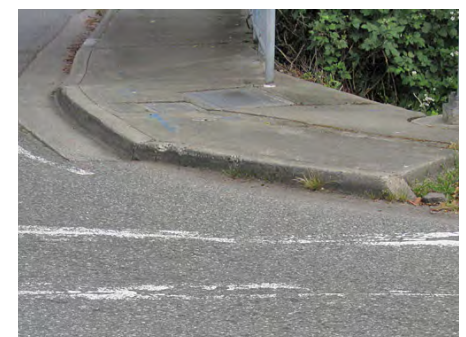
Missing ramp.

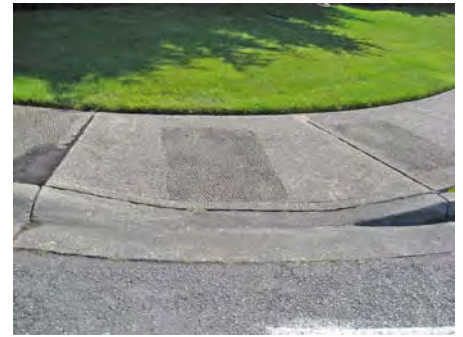
Missing detectable warning surface.

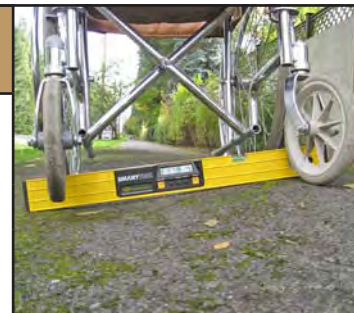
Example of 18 percent cross slope at NE 24th Street & 167th Avenue NE.

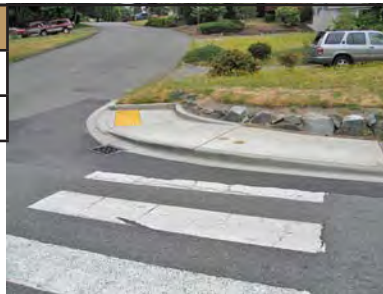
Ramp not aligned with crosswalk at Main Street & 164th Avenue NE.

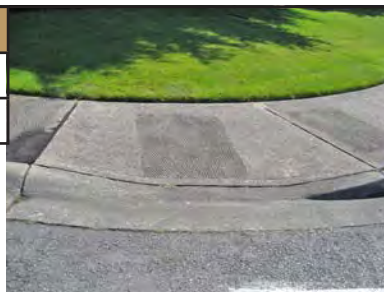
Non-standard detectable warning surface at SE 34th Street & 111th Avenue SE.

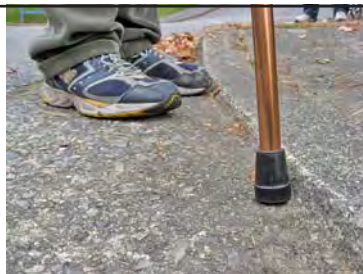
(iv) **Smooth Gutter/Ramp Transition.** Vertical changes that exceed 1/4 inch in elevation at the bottom of a ramp can cause front casters to swivel and impede the momentum needed to propel the chair up-slope at a curb ramp threshold. ADAAG 4.7.2 specifies that transitions from ramps to gutter and streets should be flush and free of level changes.

Gutter/ramp transition not smooth at SE 26th Street & 130th Avenue SE.

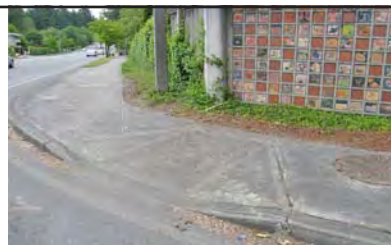
Ramp landing panel missing at 126th Avenue NE & NE 9th Street.

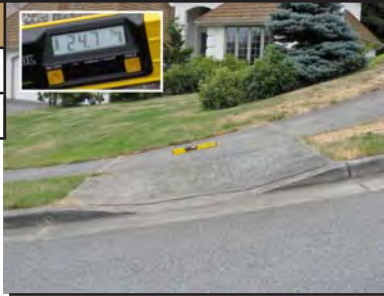
Steep ramp landing panel slope at SE 56th Street & 175th Place SE.

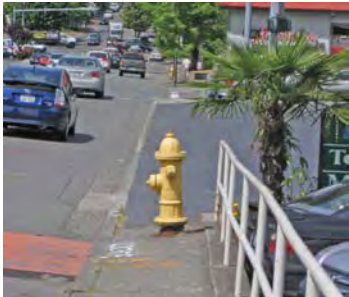
Hydrant on 3 foot sidewalk at Main Street & 107th Avenue NE renders sidewalk unusable to people with disabilities.

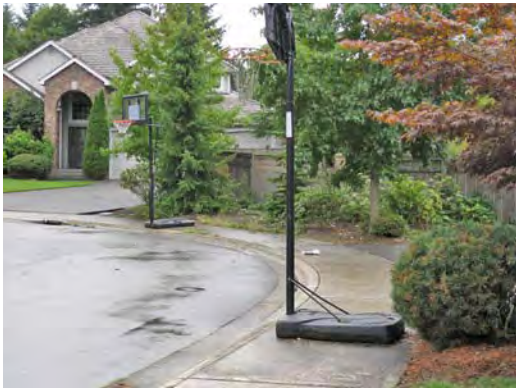
Two basketball hoops obstructing sidewalk at 159th Avenue NE and NE 24th Street.

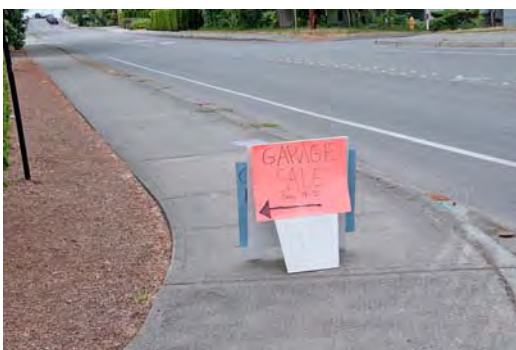
Wheelchair user is forced to use the gutter along SE 8th Street instead of the adjacent sidewalk because of a poorly placed garage sale sign at the curb ramp located at 143rd Avenue SE and SE 8th Street. In Bellevue, portable signs, including sandwich boards, are generally prohibited from the right-of-way. No signs shall be placed "so as to be hazardous to a...pedestrian's ingress and egress from...any way open to the public" (22B.20.140).

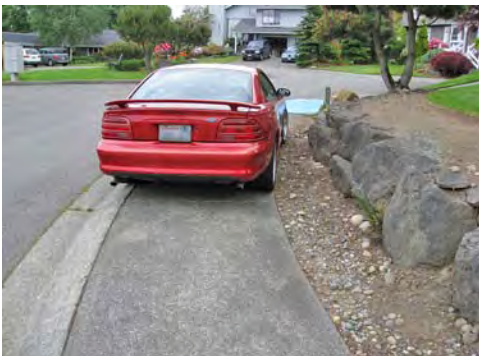
Parked vehicle obstructing sidewalk with rolled curb on SE 52nd Place.

Unlike the GMS-2 with manual entry, the ULIP methodology was not set up to allow field staff to record what specific object caused the obstruction. However, trash cans and parked cars seemed to be the most common movable obstructions. Field staff observed a higher incidence of obstructing parked cars in neighborhoods with rolled curbs as opposed to vertical curbs. Because motorists can easily drive over them, rolled curbs tend to encourage obstructive parking.

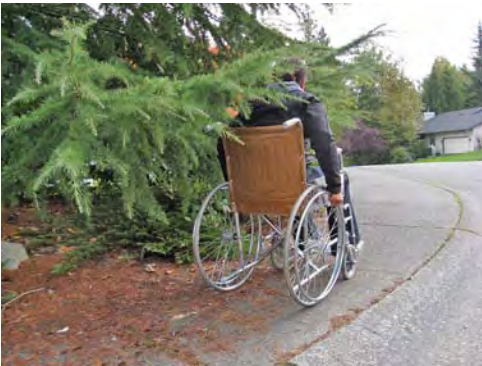
Wheelchair user struggles to traverse a sidewalk that has both vegetation and debris at 165th Place SE & SE 39th Place.

In addition to narrowing the pedestrian path of travel, unchecked plants drop debris. While there is no standard threshold for debris, ADAAG 4.5.1 requires that pedestrian surfaces be “stable, firm, and slip-resistant.” Downed branches, fallen conifer needles, leaves, and scattered gravel create uneven and slippery surfaces. The image at right shows debris fallen from trees on adjacent properties and the uneven conditions they create on sidewalks.

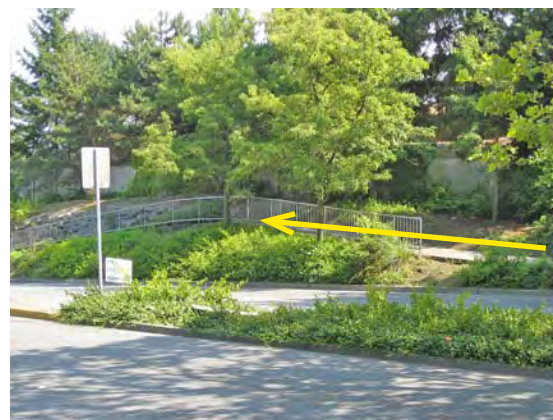
The sidewalk segment with a yellow circle around it in the ortho-image at left is again reflected in the photo above. As indicated in the image above, the sidewalk is steeper than the terrain of the streets which at this location has a grade of 5%. Given these conditions, the sidewalk is classified as a ramp type 30 in the ADA Self-Evaluation Report.
