**Toward Universal Access: Americans with Disabilities Act
Sidewalk and Curb Ramp Self-Evaluation Report
for the City of Bellevue**

September 2009

ADA Self-Evaluation Report

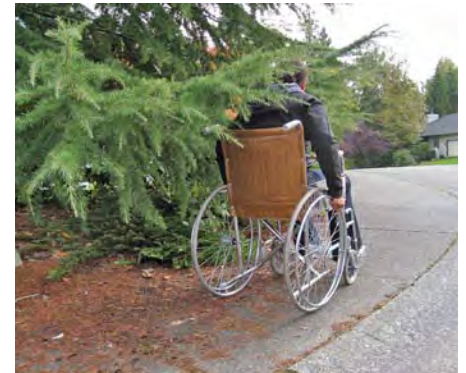
Vegetation and grade barriers.

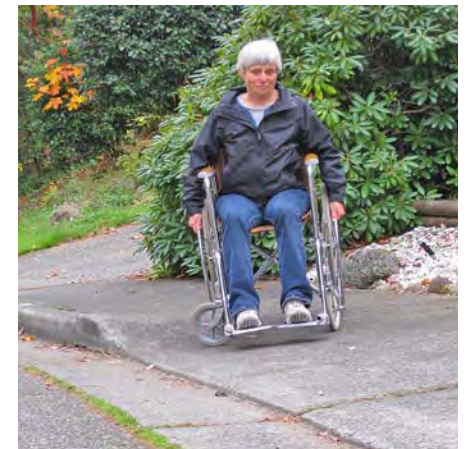
Steep driveway cross slope.

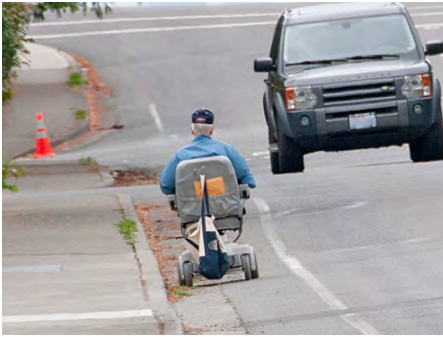
Barrier forces street use.

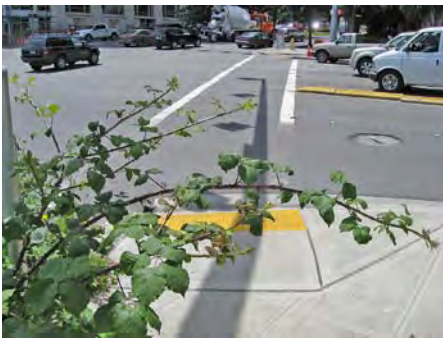
Encroaching vegetation on ramp.

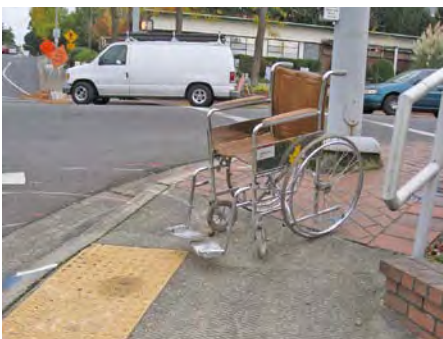
Steep ramp flare slope.

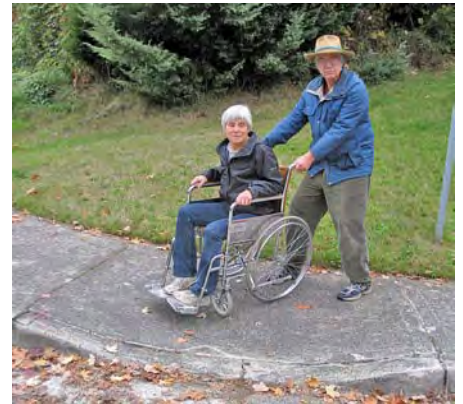
No ramp landing panel.

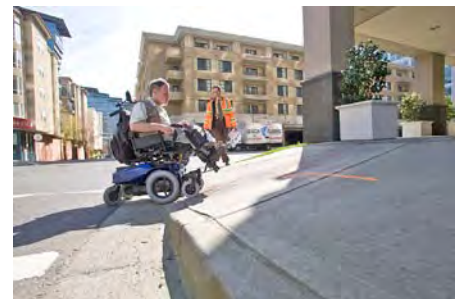
Steep ramp running slope.

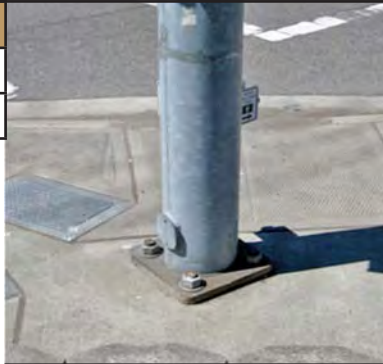
- (i) **Ramp Surface Obstructions.** Space is needed at the top and bottom of ramps so that people using wheelchairs can align with the running slope and maneuver from ramps, including when making turns (which is difficult on sloped surfaces). ADAAG 4.7.8 defines obstructions in the pedestrian environment as objects that limit the vertical passage space, protrude into the circulation route, or reduce the clearance width of the curb ramp.

Obstruction in ramp landing panel at SE 36th Street & Factoria Boulevard SE.

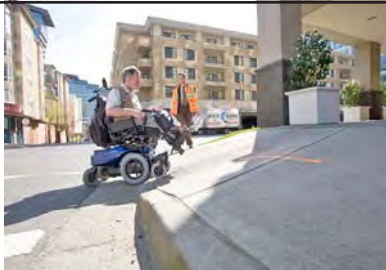
(ix) **Ramp Panel Running Slope (Grade).** The ramp panel running slope is the sloped transition between the street and the sidewalk. Steep grades are difficult for people who use walking aids and manual wheelchairs to negotiate because more energy is needed to begin and to travel on sloped surfaces. ADAAG 4.8.2 specifies that the ramp panel running slope should not exceed 8.33%.

<p><i>Steep ramp panel running slope at 109th Avenue NE & NE 9th Street.</i></p>

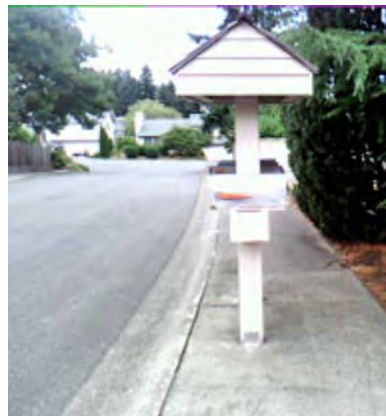
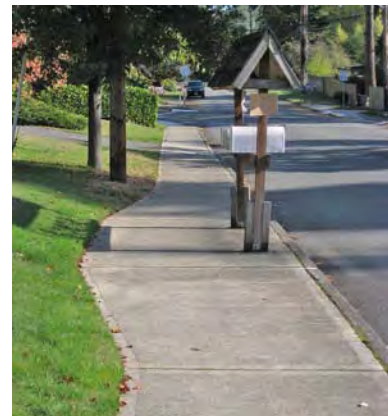
SE Cascade Key & SE Skagit Key (left); and 163rd Avenue & Lake Hills Blvd SE (right).

The City of Bellevue has implemented a number of work-around solutions to address fixed obstructions. Work-around solutions usually either relocate an obstruction or widen a small portion of the sidewalk to restore an accessible route. The examples below show work-around solutions. The top row shows an obstructing mailbox at left and a sidewalk widened to accommodate both a mailbox and an accessible route at right. The second row shows a hydrant obstructing a curb ramp at left, and a hydrant at right, located out of the pedestrian route, camouflaged by landscaping. The bottom row shows a pedestrian pole obstructing the top landing of a curb ramp at left and a pedestrian pole built into a concrete bulb out at right to accommodate both pedestrian pole access and sidewalk and landing access.

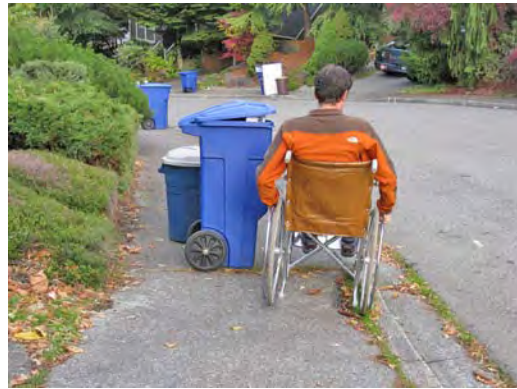
Person in wheelchair navigating on trash day at 166th Avenue SE between Phillips Rd and SE 39th Place.

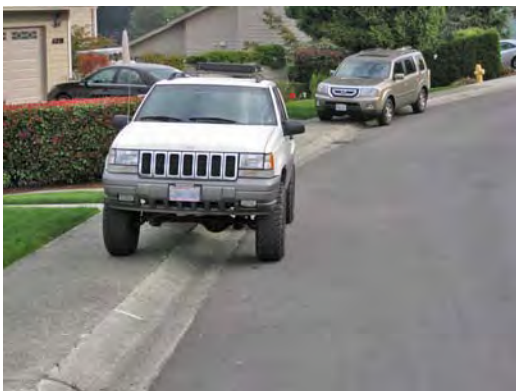
Vehicles obstructing sidewalk at SE 36th Place & Somerset Place SE.

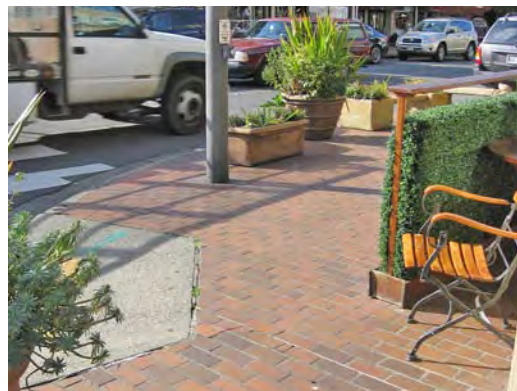
Furniture and planters at sidewalk café obstruct ramp landing and narrow the pedestrian pathway at 102nd Avenue SE & Main Street.

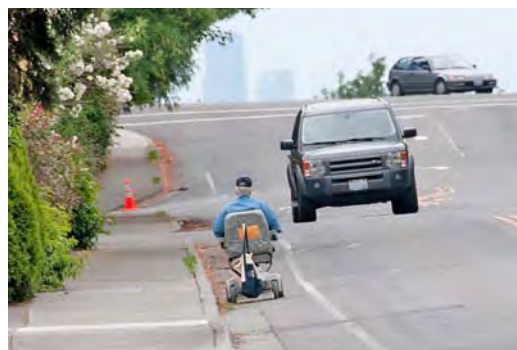
Wheelchair user is forced to use the gutter along SE 8th Street instead of the adjacent sidewalk because of a poorly placed garage sale sign at the curb ramp located at 143rd Avenue SE and SE 8th Street. In Bellevue, portable signs, including sandwich boards, are generally prohibited from the right-of-way. No signs shall be placed "so as to be hazardous to a...pedestrian's ingress and egress from...any way open to the public" (22B.20.140).

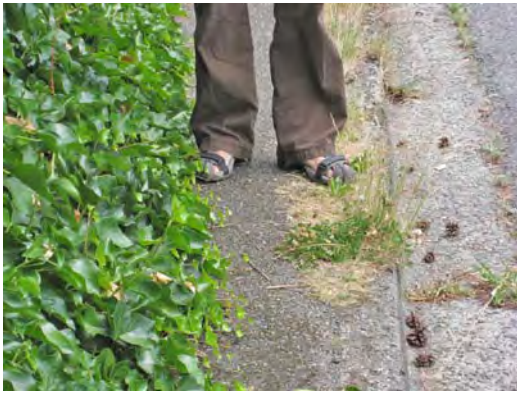
150th Place & 45th Street SE.

Vegetation is a subcategory of movable obstruction and is by far the most common obstruction on Bellevue's pedestrian network. When bushes or tree branches force pedestrians to turn back or move into the path of automobile traffic, they present serious obstacles to accessibility. The Bellevue City Code requires property owners to trim back vegetation on their property so that it does not "obstruct or impair the free and full use of the sidewalk or street" (BCC 14.06.010). The photos below show a variety of vegetation obstructions in Bellevue.

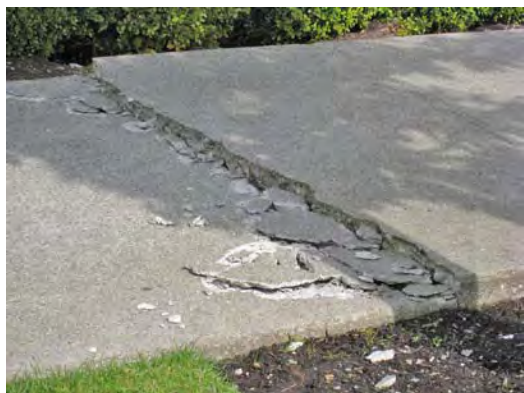
Two inch change in level in a concrete sidewalk at 58th Place & SE 58th Street.

The guidance from ADAAG 4.5.2 on changes in level is as follows: (i) up to 0.25" - no modification required; (ii) 0.25 to 0.5 inches - bevel the surface with a maximum slope of 50 percent; and, (iii) greater than 0.5" - install a ramp with a maximum grade of 8.3 percent. Bellevue relied on its Ultra-Light Inertial Profiler (ULIP) to identify sidewalk locations with changes in level that exceed ADAAG standards using laser, accelerometer, and distance measurements. Before the final output is produced, the laser height data is first filtered to remove signals resulting from cracks/joints/gaps/grating and surface debris. Then the software searches for non-standard sidewalk faults (heaving) and transitions (bevels). Finally the software produces a file compatible with the city's computerized mapping system.

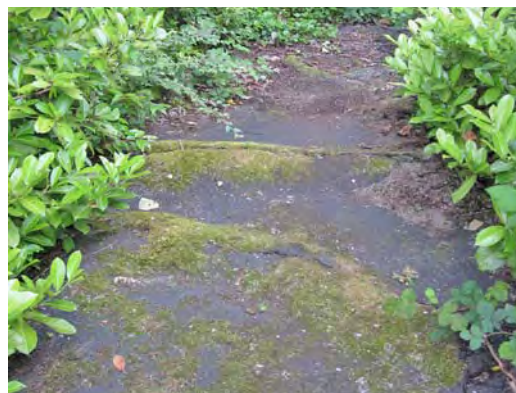
Change in level in an asphalt sidewalk at SE 27th Street & 124th Avenue SE.

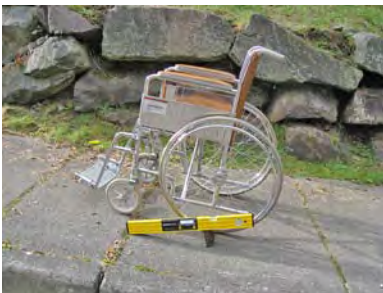
Sidewalk grade of 22% on 166th Avenue SE between Phillips Road and SE 39th Place.

Steep sidewalk grades are a barrier for many pedestrians. Powered and manual wheelchairs can become unstable and/or difficult to control on sloped surfaces. These areas are even more difficult for sidewalk users who are disabled to access when wet.

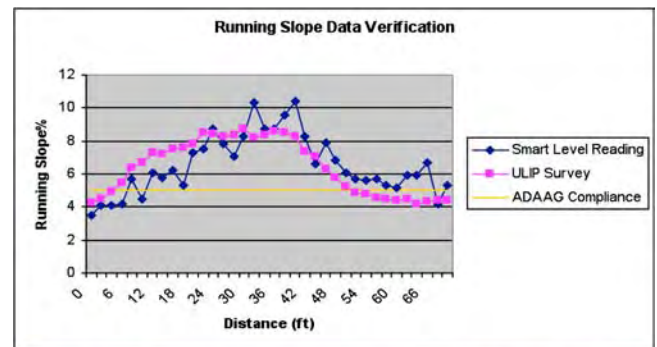
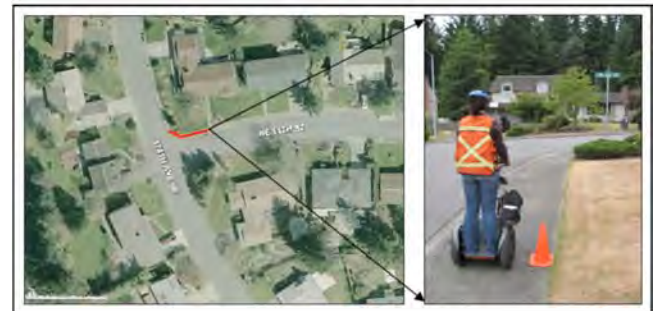
During the sidewalk inventory effort, the City employed a rigorous QA/QC protocol for validation testing of the data results. Field verification of ULIP results involved taking smart level measurements of sidewalk grade every 2 feet over a 70 foot span. Numerous assessments of ULIP data, evaluated at the same interval as the smart level (2 feet), confirmed that the ULIP grade data provides an accurate interpretation of the geometry of the sidewalk profile. The images above reflect the results of a field test of ULIP sidewalk grade at 174th Avenue NE and NE 11th Street.

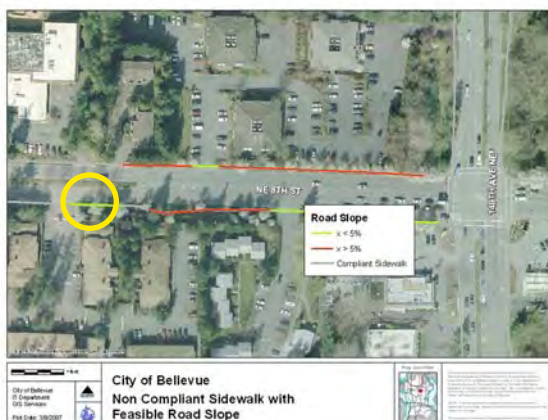
The sidewalk segments (depicted in both red and green) along NE 8th Street and 148th Avenue NE were initially classified as having non-standard ADAAG grade values. After running its GIS script, Bellevue reclassified those sidewalk segments where the adjacent road grade is greater than 5% (red) as technically infeasible. Sidewalk segments with non-standard grades and adjacent to road grades that are less than 5% (green) are identified as a barrier in the ADA Self-Evaluation Report.

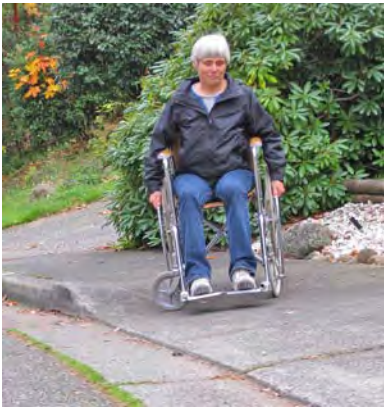
A series of driveway apron flares with 11% cross slope measurements at 130th Avenue SE & SE 26th Street.

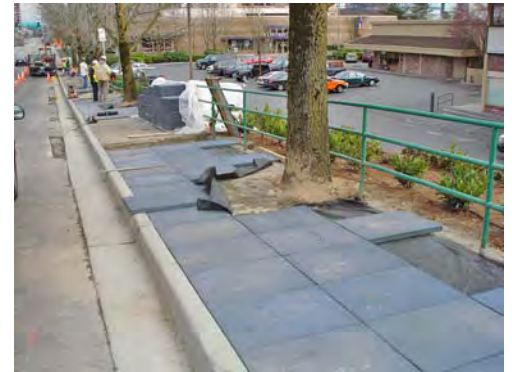
Rubber sidewalk panels at NE 10th Street west of 102nd Avenue NE allow tree roots to grow under the sidewalk without creating a change in level barrier for people with disabilities.

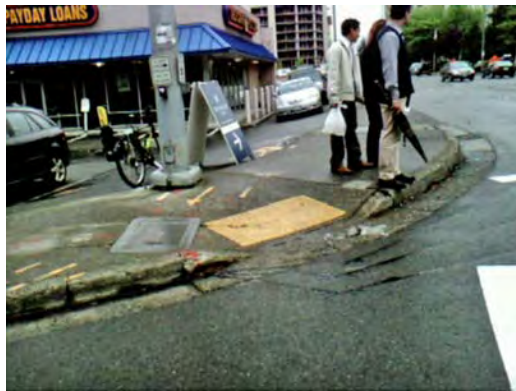
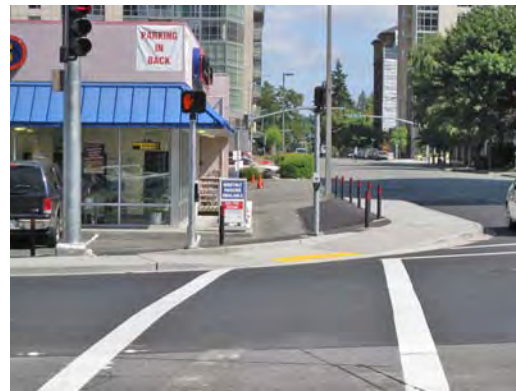
Inventoried during the 2008 ADA field inventory effort, Block ID: 1035, was subsequently improved as part of the NE 8th Street widening project (Winter-Summer 2009). A new sidewalk and curb ramps were built next to the new westbound lane. As indicated in the before and after images below, the project enhanced pedestrian facilities by removing fixed obstructions and improving sidewalk surface conditions (both changes in level and slope variations). This was an important project because it addressed barriers to accessibility in a downtown Bellevue location known to have high volumes of pedestrians.

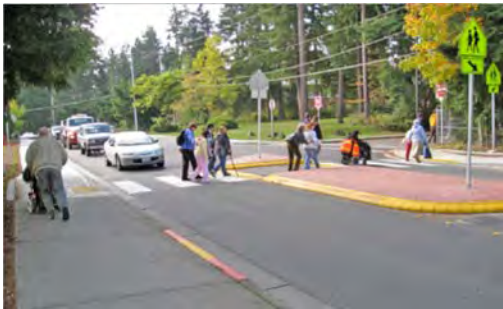
Pedestrian median with a cut-through design provides people with disabilities a point of refuge when crossing at 164th Avenue NE south of NE 24th Street.

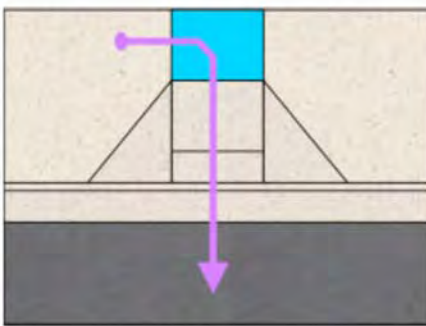
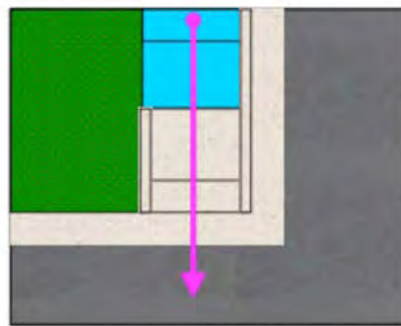
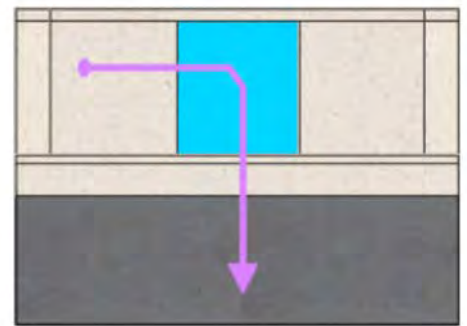
Locations: NE 24th and NE 167th

panels are a place where pedestrians will pause and reorient themselves either toward the sidewalk (in the case of a perpendicular ramp) or toward the street, these spaces should be flat. The field team found that 2,791 (79%) of the 3,511 existing ramps had non-standard ramp panel slopes of greater than 2%.

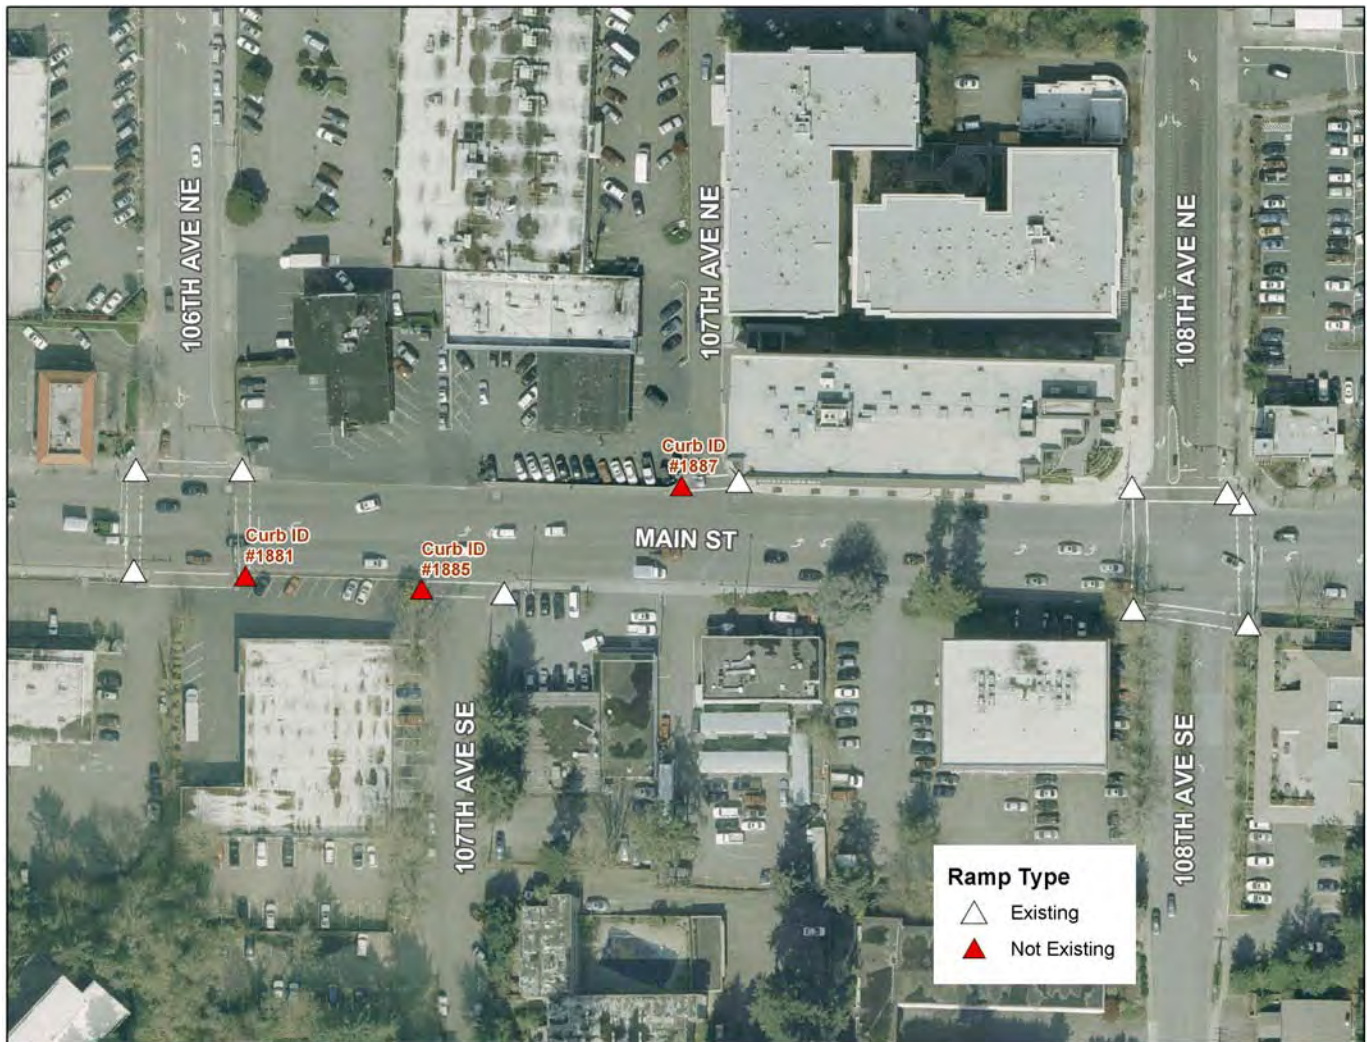
The following Main Street locations in the curb ramp inventory received the three highest barrier ranking scores: Curb ID: 1881 at 106th Avenue NE; Curb ID: 1885 at 107th Avenue SE; and, Curb ID: 1887 at 107th Avenue NE. Each of these locations received a high impedance score (100 points) because ramps are missing and they have a high activity score (81 points) because this location serves as a major connection to many destinations in downtown Bellevue.

In 2008, the City of Bellevue initiated a conceptual design project for Main Street from Bellevue Way to 116th Avenue NE. Work includes lane configuration options, enhanced pedestrian-bicycle facilities, potential open space opportunities and a framework for downtown gateways. The early-stage designs of proposed projects along this corridor all include accessibility enhancements, including the ramp locations identified in the ADA Self-Evaluation Report.
