# City of Bellevue 2014 Electric System Reliability Review

**August 6, 2015**

# 2014 Bellevue Reliability Overview

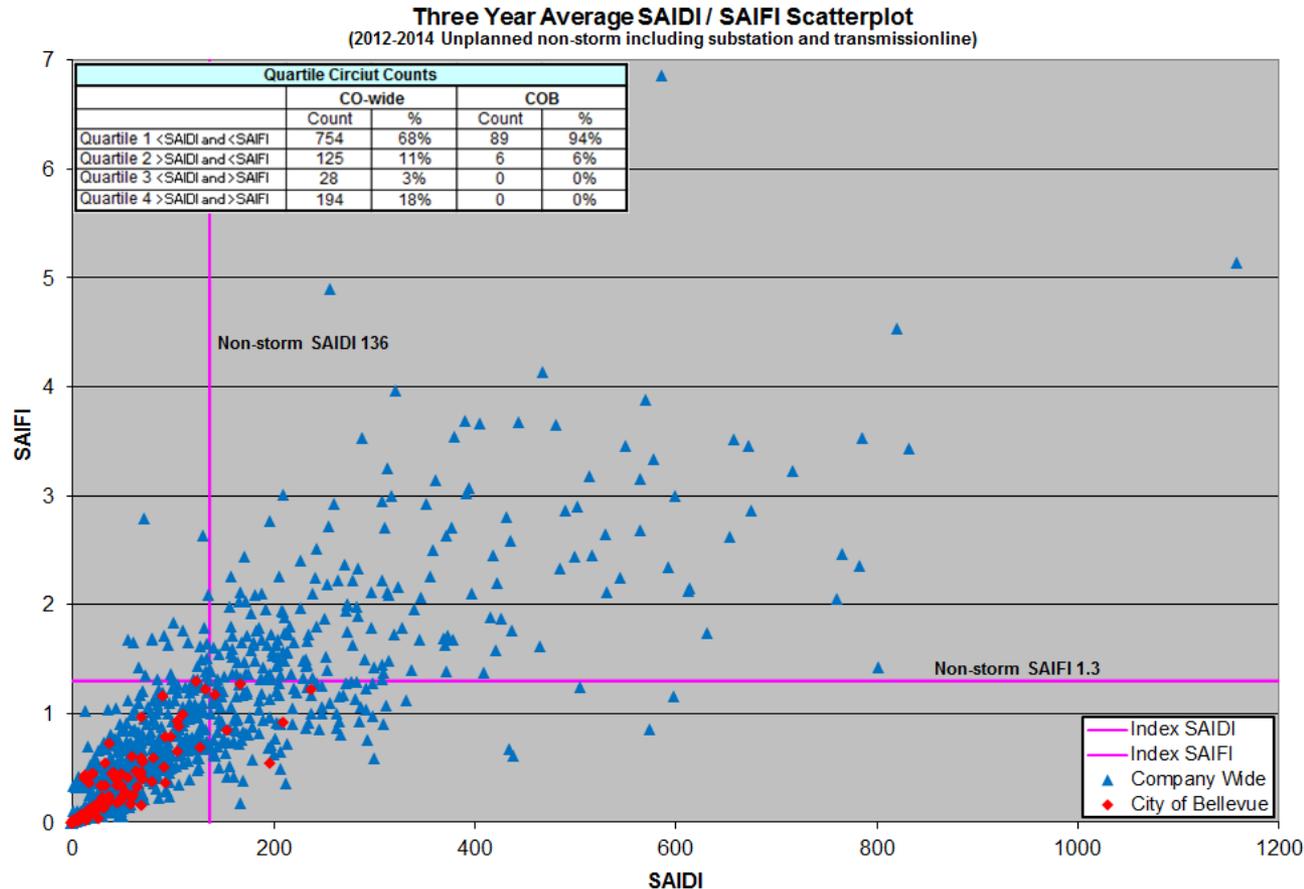
# 2014 Bellevue Reliability Overview

All but 6 circuits serving Bellevue had performance within the 1<sup>st</sup> quadrant

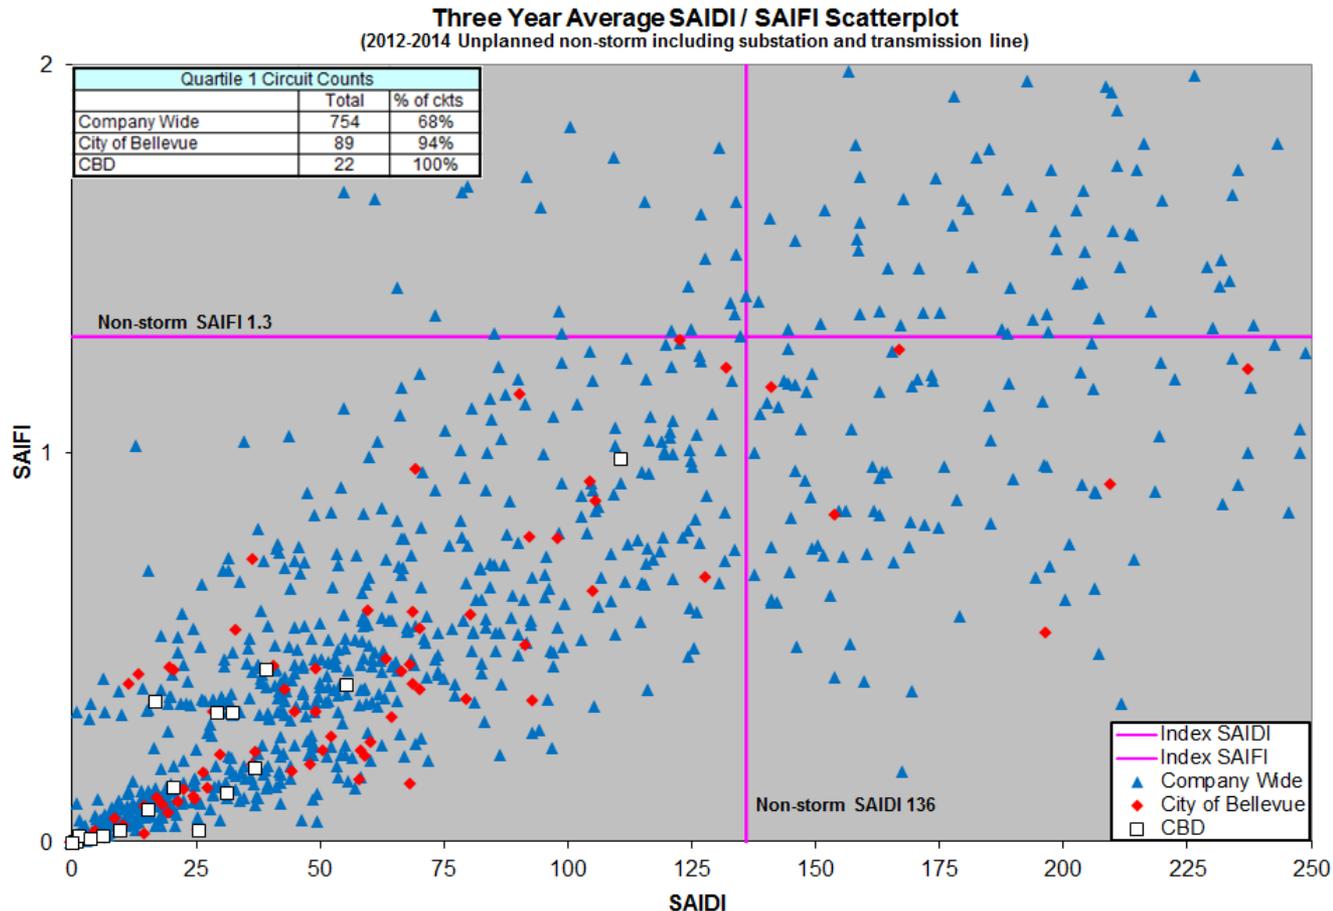
# 2014 Bellevue Reliability Overview

All circuits serving the CBD were within the 1<sup>st</sup> quadrant
